DELAWARE RIVER BASIN
BRANDYWINE CREEK,
NEW CASTLE COUNTY
DELAWARE

COOL SPRINGS RESERVOIR DAM DE 00014

PHASE 1 INSPECTION REPORT NATIONAL DAM SAFETY PROGRAM

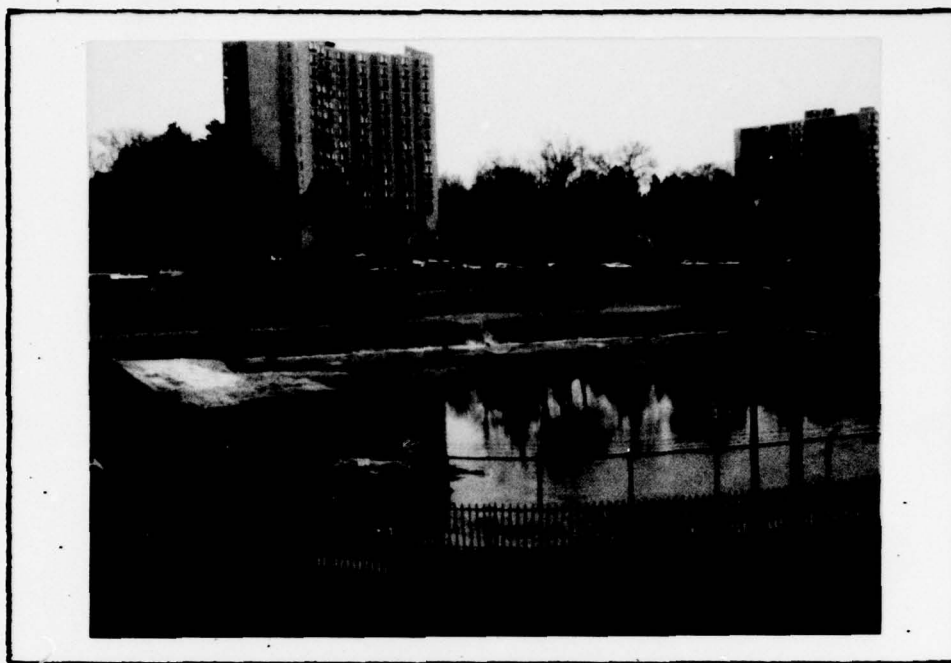
*OVERVIEW OF COMPLETED REPAIRS
ON COOL SPRING RESERVOIR APRIL 1978*

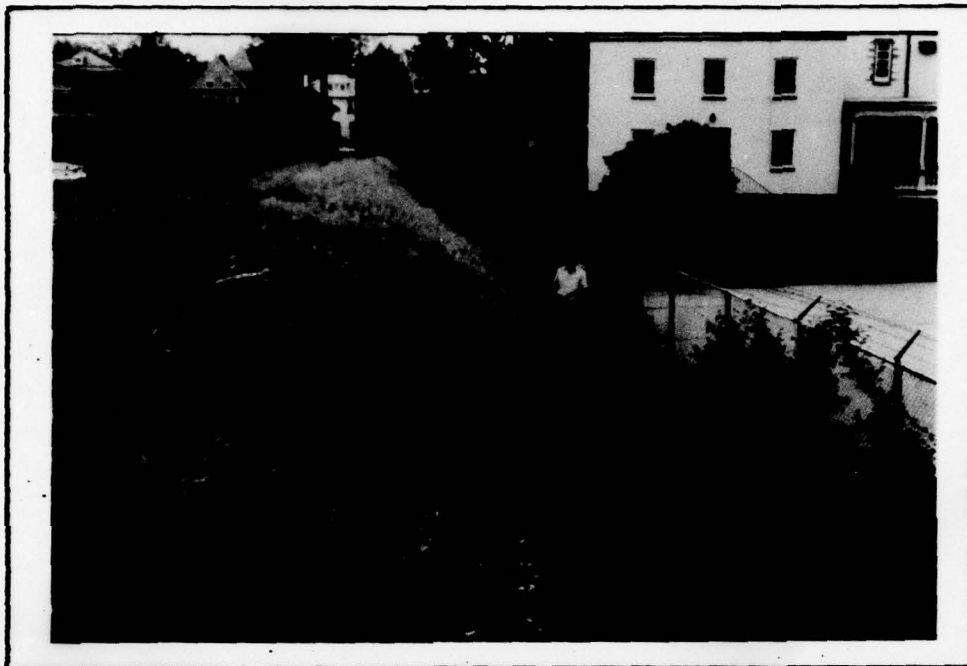
*NORTH SIDE OF THE RESERVOIR SHOWING
EXCELLENT VEGETATIVE COVER 5/24/79*

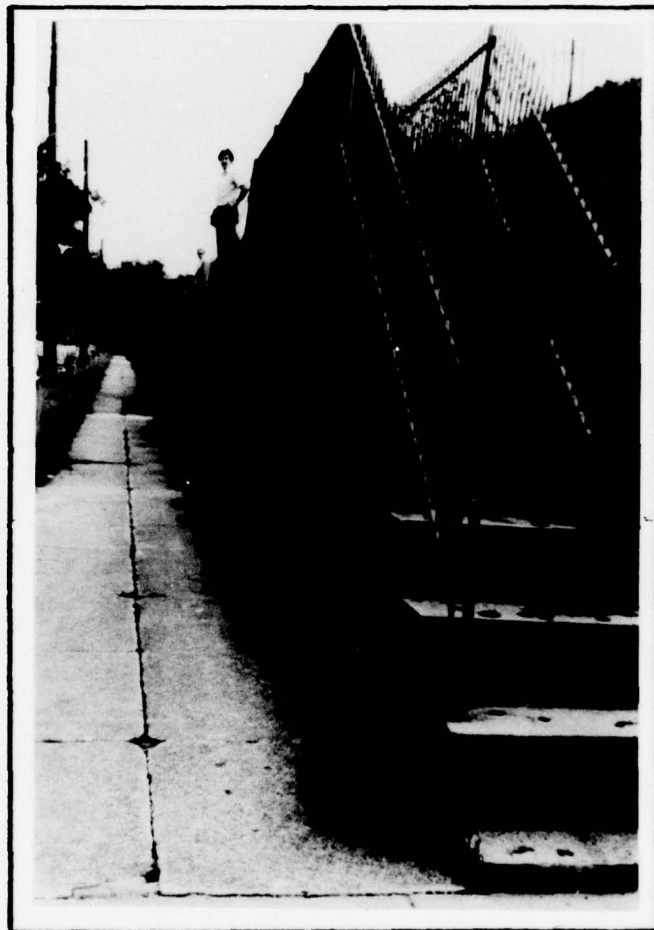
The continued loss of stone blocks and mortar from the 10th Street slope retaining wall could eventually cause its failure and that of the embankment. However, it was evident during the visual inspection that some repointing of the wall has been performed since its original construction.

TENTH STREET (SOUTH) SIDE 5/24/79
OF THE RESERVOIR SHOWING
THE STONE MASONRY RETAINING WALL

(3) The stone masonry retaining wall supporting the 10th street slope should be repointed and the missing stone blocks replaced to maintain the wall's structural integrity. According to the Owner's representative, this work is presently under way.

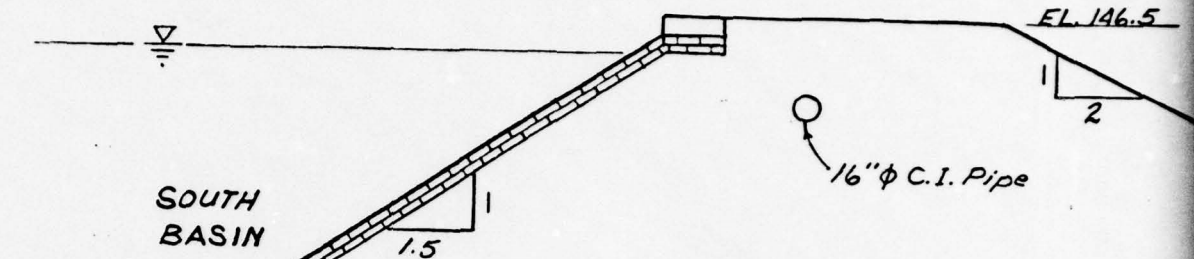
SECTION A-A

VAN BUREN ST. (East) SLOPE

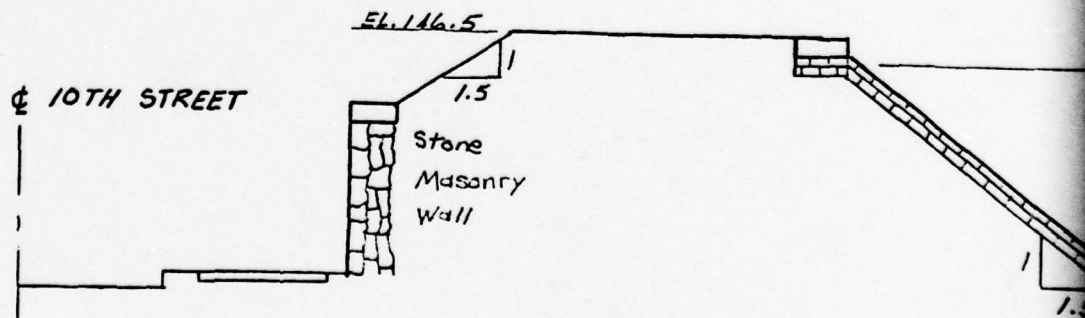
SECTION B-B

10TH ST. (South) SLOPE
